# Retrofitting Hospital Workers Co-operative

A TOWERWISE CASE STUDY

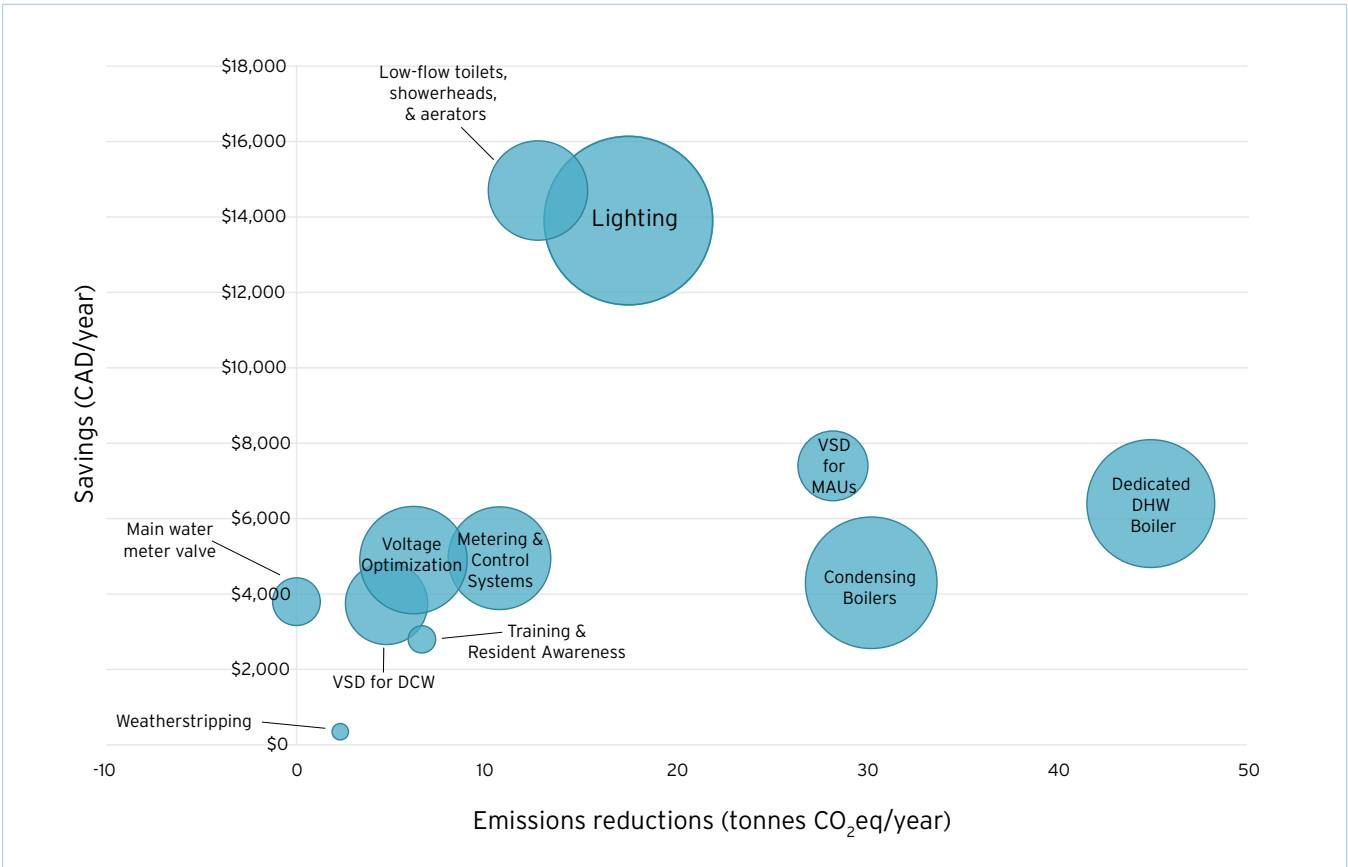
Figure 1: Estimated annual RCM savings, carbon emissions reductions, and measure costs

Projected cost and carbon emission savings from all RCMs can be seen in Figure 1. The circle size reflects the full capital cost including design, equipment, installation, and commissioning. This project implemented a variety of measures with varied paybacks in order to maximize utility cost savings and carbon emissions reductions.

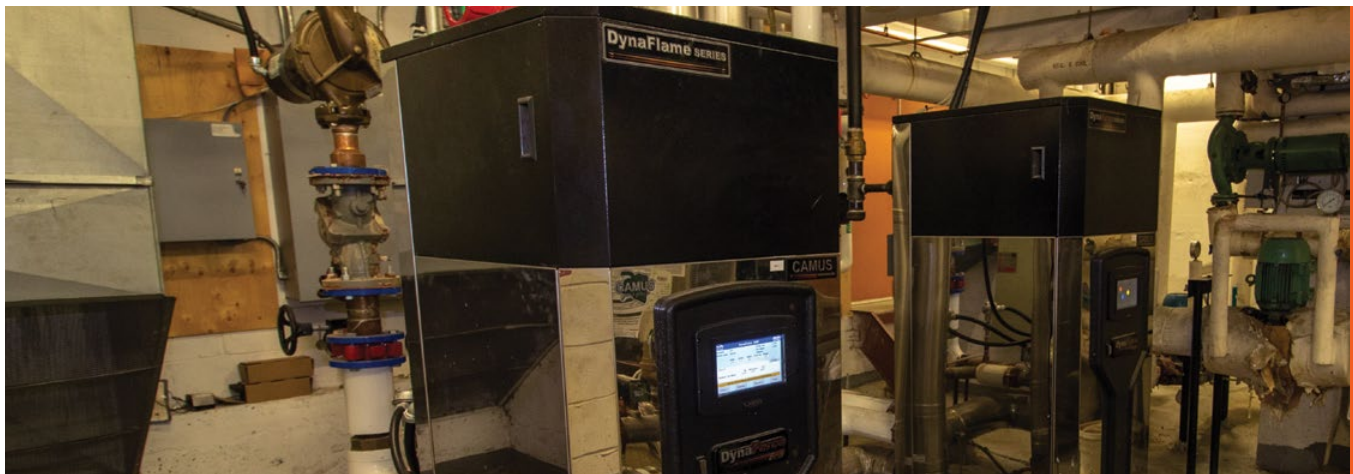
**Figure 6:** New boilers for space heating

Prior to the retrofits, space heating and DHW were provided to the building from one central heating plant. Three gas-fired, copper-fin Teledyne Laars boilers provided 2,450 MBTU/hr of heating input each. The existing boilers were original to the building, and over 18 years old. Though the boilers had some modulating capabilities, this was limited with a minimum firing rate of 30 per cent. In addition, the project team noted during on-site visits that the existing Tekmar controller required a review of its programming and setpoints.

As the DHW load was being supplied by the main boilers used for space heating, this meant that those boilers had to operate even in the summer months. With such a small summer load, the boilers were running inefficiently due to increased cycling. This presented ample opportunity for energy savings through the introduction of a dedicated DHW boiler.

The three existing boilers were replaced with two 2000 MBTU Camus Dynaforce boilers for space heating, and two smaller 1000 MBTU/hr for DHW. Condensing boilers have rated efficiency of 90-95 per cent, and with a 5:1 turndown ratio, their minimum firing rate is only 20 per cent. By separating the loads, the larger space heating boilers will only be operated during the heating season, resulting in an estimated 14 per cent reduction in gas used for space heating.

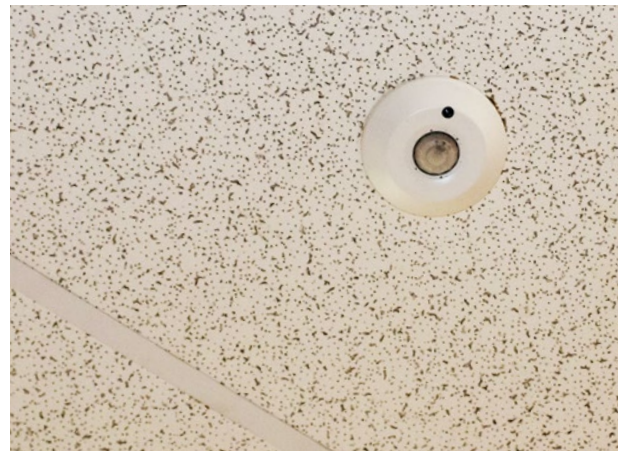
**Figure 8:** Motion sensor located in laundry room.

Ceiling mounted occupancy sensors were also introduced into laundry rooms, garbage chutes, and the bike room, to ensure that lighting would only be used in these areas when occupied.

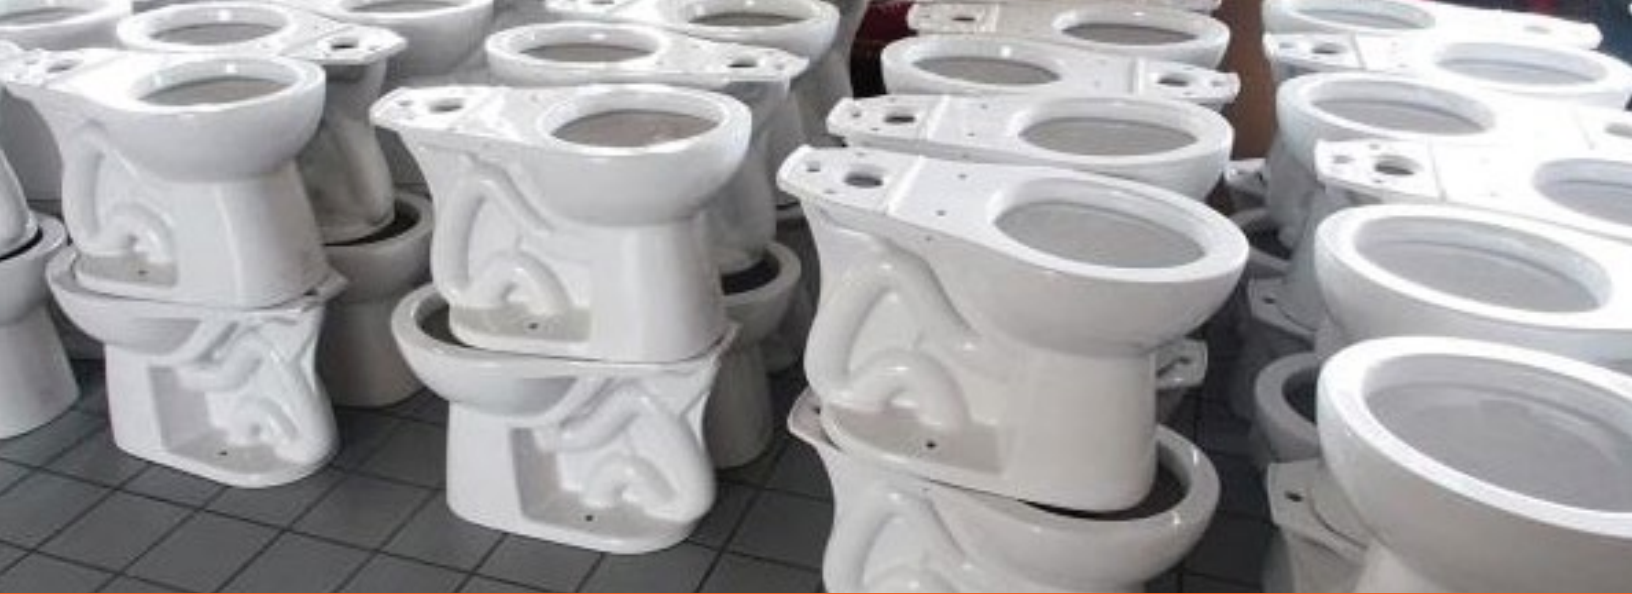
A number of measures were taken to help reduce water usage in suites and common areas, including low-flow toilets, showerheads, and aerators.

The existing toilets were rated at 6L per flush and were upgraded to 3L per flush low-flow toilets. Similarly, the original showerheads had been rated between 5.7-7.6 litres per minute and were replaced with 5.7 litres per minute fixtures. Existing sinks were rated between 3.8-8.3 litres per minute. These were replaced with 3.8 litres per minute aerators in the bathrooms, and 5.7 litres per minute aerators in the kitchens.
