TowerWise

Case Study:

849 Broadview Avenue

Figure 1: Upper Broadview Suites

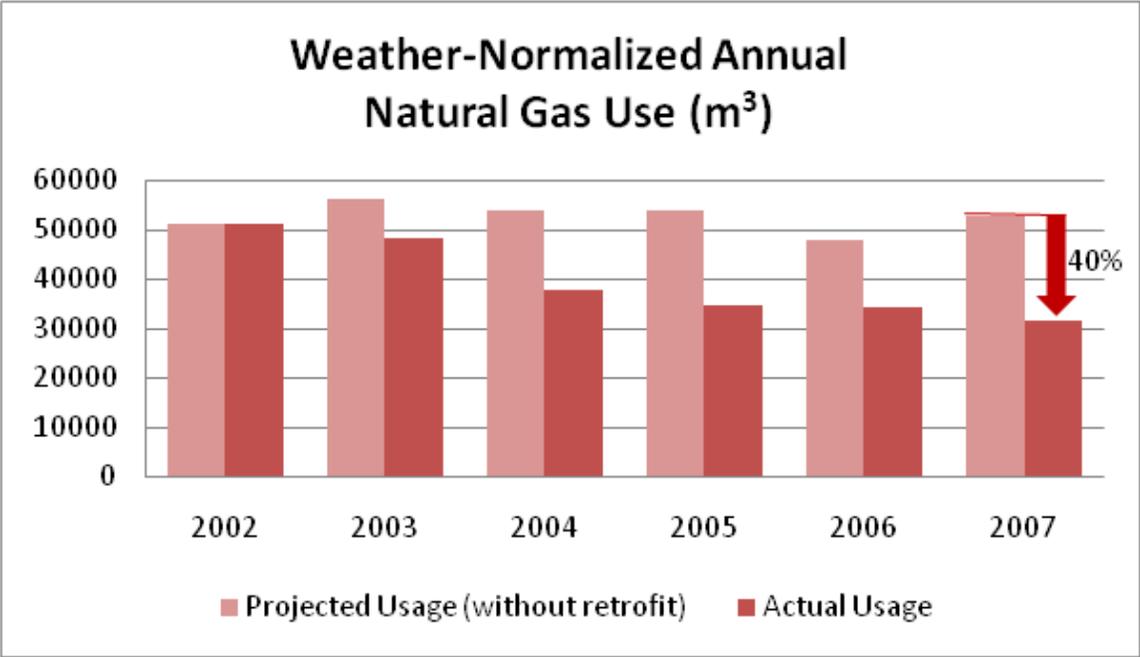
Figure 2: Weather-Normalized Annual Natural Gas Usage [1][2]

As of 2007, the retrofit measures have reduced the building’s natural gas consumption by about 40% from the baseline year of 2002, as shown in Figure 2. The projected usage in Figure 2 is weather adjusted for heating degree days (HDD) from the gas usage observed in the baseline year.

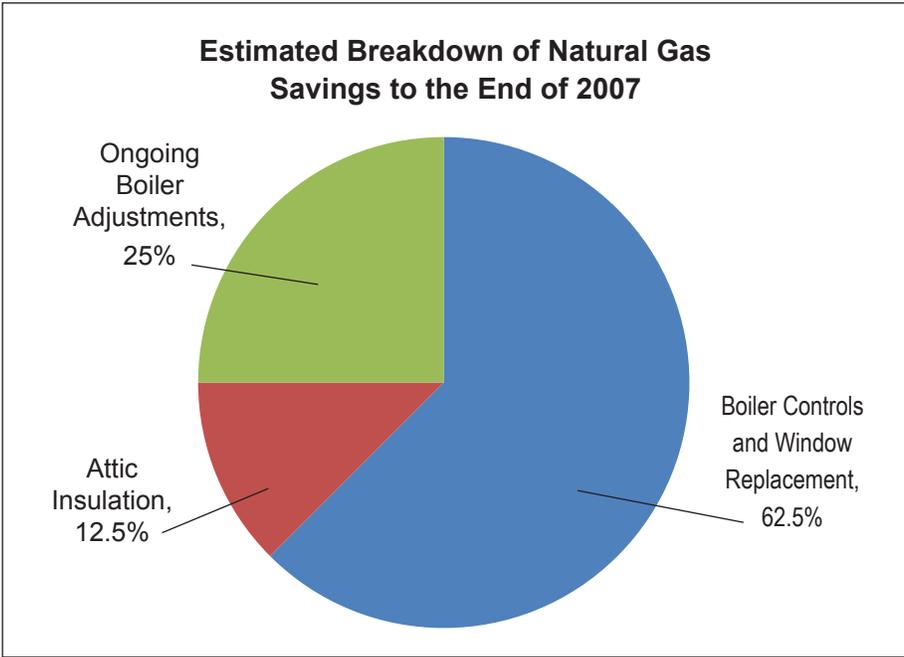
Figure 3: Breakdown of Natural Gas Savings

Both the boiler controls and windows were replaced in the spring and summer of 2003 and insulation was added to the attic space in June 2004. As both of these projects occurred in the summer and two-thirds of a year’s HDDs likely occur in the first half of the year [2], the estimated savings associated with replacement of the boiler controls and windows consists of the savings seen in 2003 and two-thirds of the 2004 savings or about 3.5 m³/HDD each year, as shown in Figure 3.

Likewise, the savings attributed to the attic insulation occurs in the remaining one-third of 2004 savings or about 0.7m³/HDD. The owners indicated that there have also been ongoing modifications to controls and operation of the boiler to optimize heating system performance. As no other retrofit measures have been made to the building that would affect gas use and central control of the boiler system is maintained by the owners (as opposed to unit-level control by tenants) the remaining gas savings between 2005 and 2007 have been attributed to these modifications. This has likely contributed to an understatement of the savings achieved by the attic insulation because it is unclear when

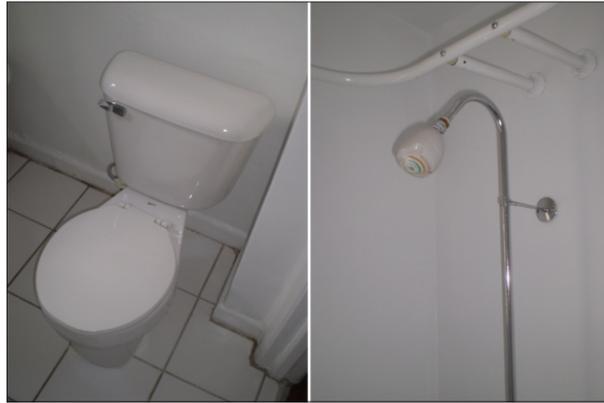
Figure 4: Low flow toilets and showerheads

The toilets and showerheads were replaced and low flow aerators added to all faucets in November 2006, which resulted in a 50% reduction in water use the following year as shown in Figure 7. The 2005 data was excluded from the baseline average because there was a small leak underneath the building that year and a suspected problem with the water meter, which was also replaced in 2005. Both of these factors likely contributed to the anomalous usage in 2005, and savings would have been overstated had it been included.

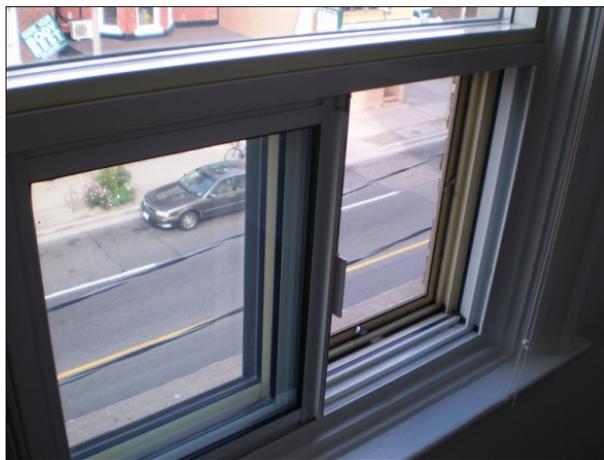
Figure 5: White vinyl window frames

In addition to natural gas savings, the windows also enhance the appearance of the suites with white, vinyl frames replacing old metal ones. The new windows also contributed to quieter, more comfortable suites.

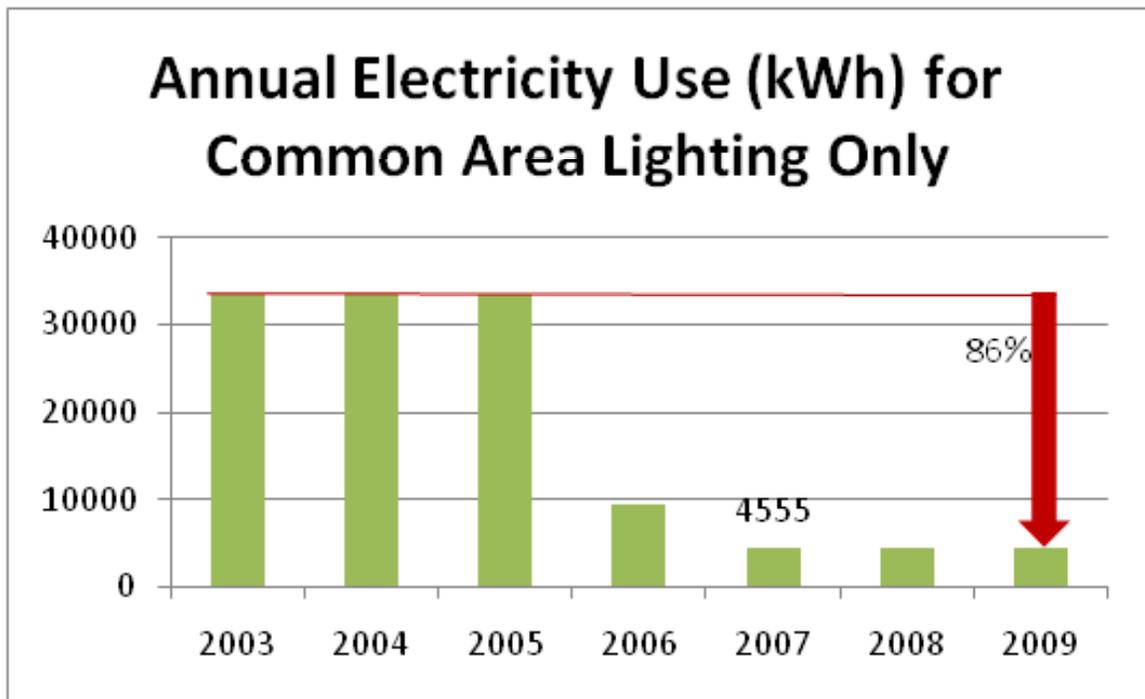
Figure 8: Annual Electricity Use for Common Area Lighting

In February 2006, the existing F40-T12 fluorescent bulbs used for common area lighting were each replaced with two 13W compact fluorescents. This retrofit of 192 existing fixtures resulted in an 86% reduction in electricity consumption associated with common area lighting, as shown in Figure 8. As the building is not sub-metered, savings were calculated by determining the electricity consumption of the pre and post-retrofit lighting fixtures, assuming that common area lighting is on 24 hours a day, seven days a week.

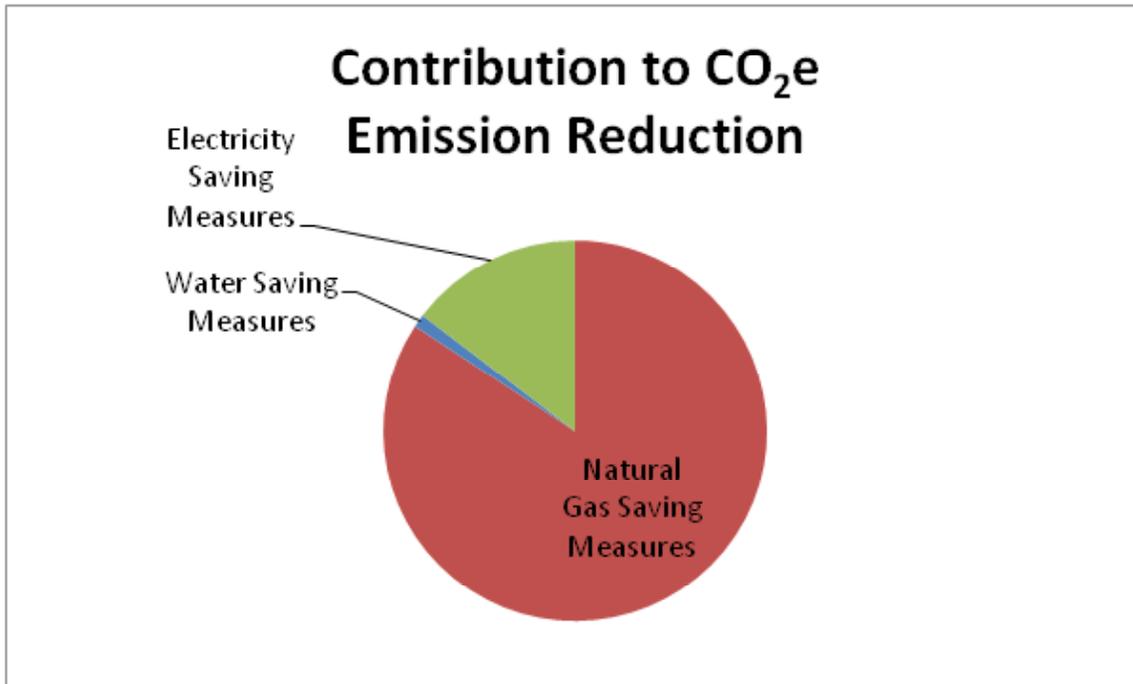
Figure 9: Impact of Resource Saving Measures on CO₂ emissions

In addition to improved thermal comfort for tenants and more efficient building operation, saving natural gas, water and electricity also helps avoid CO₂ emissions. Annually, the natural gas savings resulted in over 40 Tonnes of CO₂e avoided [3], while water and electricity savings contributed to 0.5 [4] and 7 Tonnes [3], respectively as shown in Figure 9. The combination of all of the implemented measure is estimated to result in an annual reduction of CO₂e of approximately 48 Tonnes.

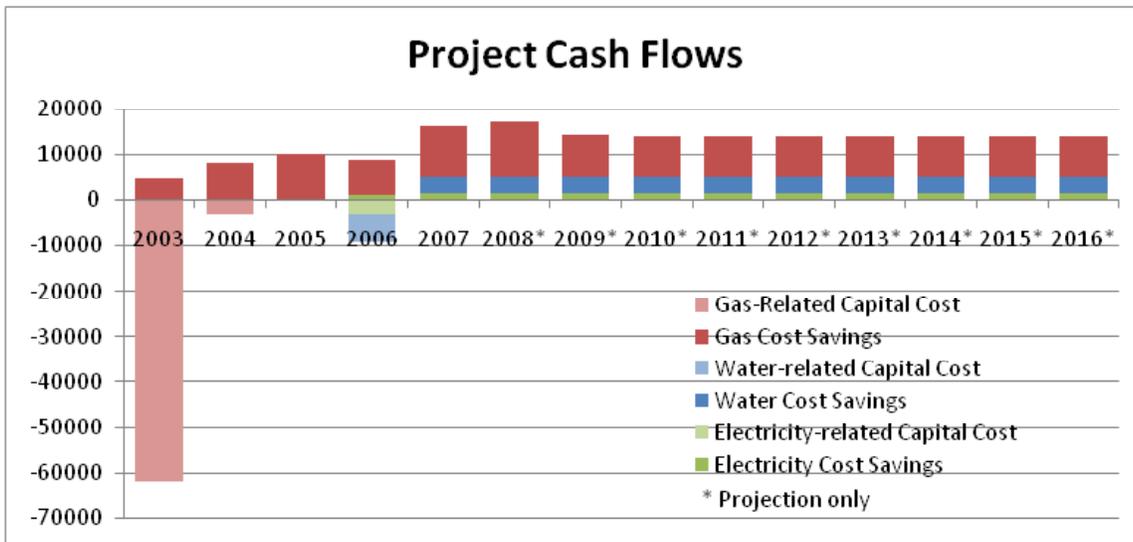
Figure 10: Project Cash Flows [1][2]

In order to examine the simple payback, return on investment (ROI), internal rate of return (IRR) and net present value (NPV) of the retrofits, a cash flow diagram is presented in Figure 10 with capital expenditure as negative cash flows and annual cost savings as positive cash flows.

Annual gas cost savings are generated from the difference between actual annual consumption and projected annual consumption. Projected annual consumption was derived using a pre-retrofit baseline year of 2002, and adjusting that 2002 usage according to the HDDs of the subsequent years to determine how much energy *would* have been used had there been no retrofit. Given that both of the gas conservation measures (boiler control and window replacement and attic insulation) were completed during the summer months, the savings in 2003 was accrued only in the latter half of the year. Likewise, only savings in the latter half of 2004 is affected by the attic insulation, which was added in June.
