Lessons from a Heat Pump Retrofit at CityHousing Hamilton

A TAF CASE STUDY | 2022

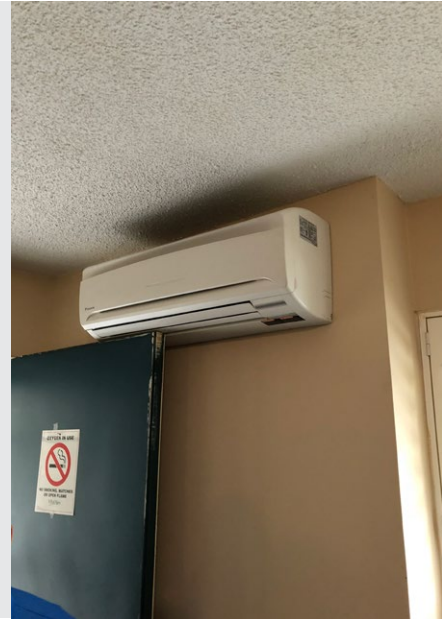
Figure 2: In-suite heat pump configuration of a one-bedroom suite

Based on size and configuration of each suite, TAF recommended large open-concept zones be served by one indoor head, with an additional head in sufficiently large bedrooms. In the suites with smaller bedrooms, we recommended placing single heads in corridors facing bedroom and bathroom doors. The living room units were well-situated, mounted to the upper wall corners to deliver sufficient space conditioning to the open concept living room, kitchen, and foyer space. Ultimately, we followed the recommendation from the manufacturer and contractor to serve each zone with its own head, including the small bedrooms in RS2 and RS3.

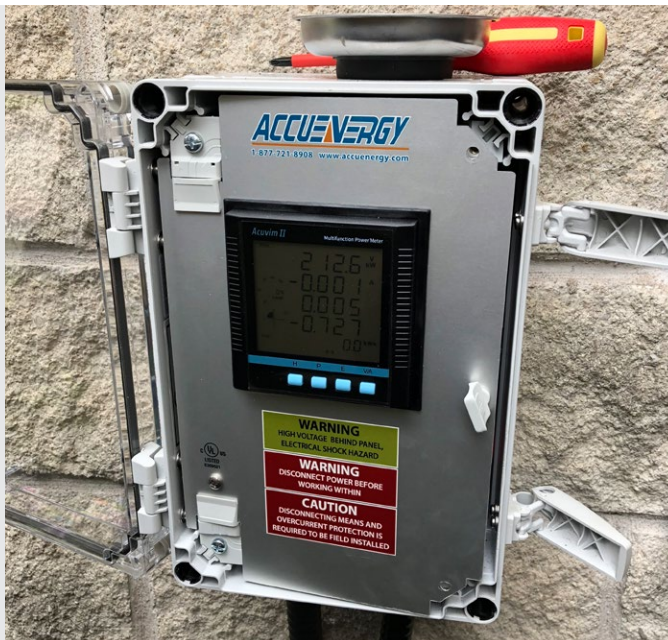
The Accuvim IIR has the CTs and fused terminal blocks for voltage connections pre-wired and pre-configured. The AcuMesh allows wireless connection between RS-485 supported devices and the Accuvim Power meter raw data. This is done by connecting a computer device on-site with the meter's real-time data through the online portal. The historical data can be accessed and downloaded as CSV files.

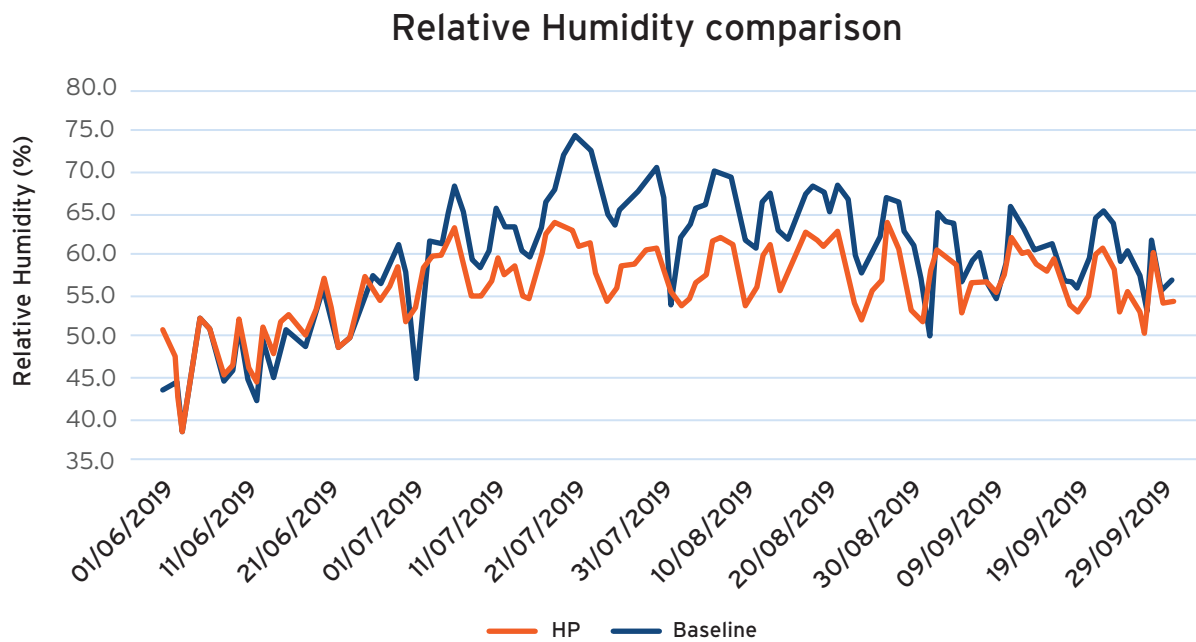
Humidity levels are very similar for both the baseline and retrofitted units. This is largely because humidity is dependent on factors other than just the heating and cooling systems. The number of occupants and their daily habits can have a big impact as well as the air tightness of the building envelope and efficacy of the bathroom and kitchen range hood ventilation systems.
